Cracking On Bend

Learn how our Material Support & Solutions team solved this customer material issue.

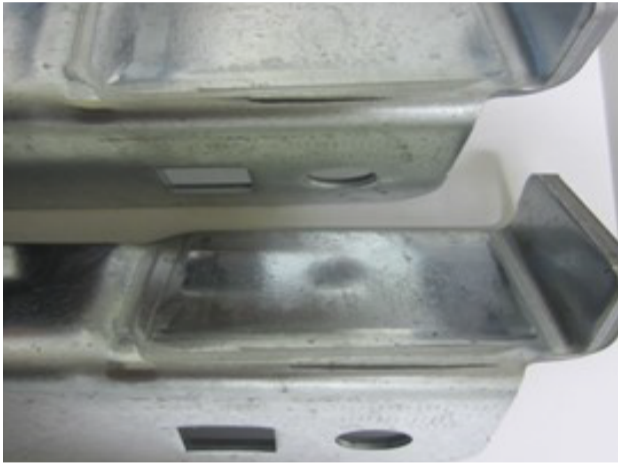
A customer faced challenges with a new part made from galvanized steel. Despite meeting their specifications, the steel exhibited fracturing and peeling of the protective zinc coating in the forming process. This led to material loss and unplanned sorting.
