# Resolving Punch Failures

Learn how our Material Support & Solutions team solved this customer material issue.

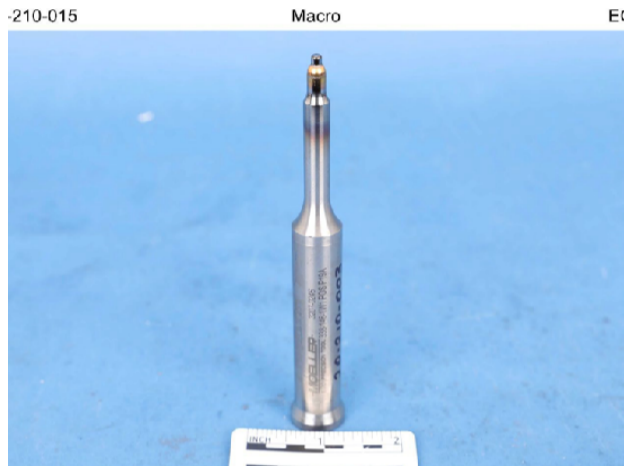
The punch life in a customer's die decreased significantly from 700,000 hits to less than 20,000 hits. These punch failures resulted in lower productivity and required sorting to remove non-conforming parts.

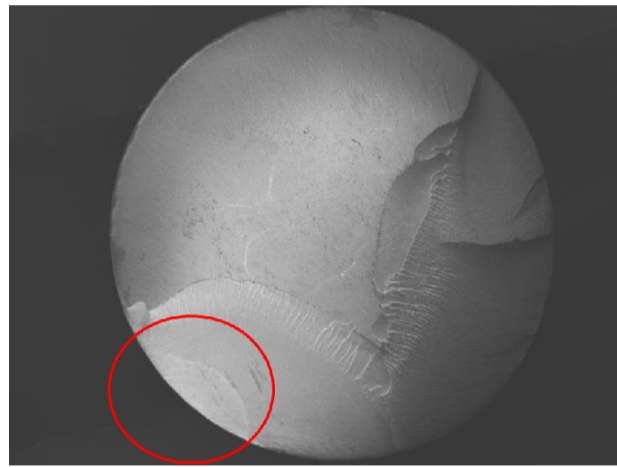
Titanium carbonitride coating thicknesses and surface hardness's of new and used punches were evaluated. In addition, fracture surfaces of broken punches were examined. The coatings on the punches with premature failures were found to have accelerated wear.

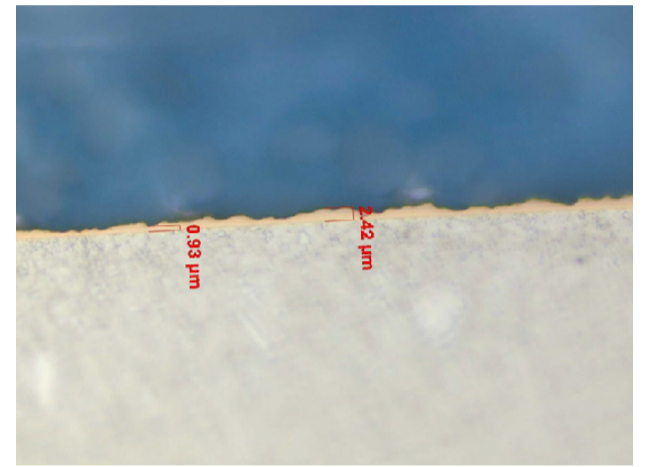
The accelerated wear was due to insufficient coolant during the highspeed stamping process. Process controls were implemented, and punch life returned to 700,000 hits.
