Shear-break Issue

Learn how our Material Support & Solutions team solved this customer material issue.

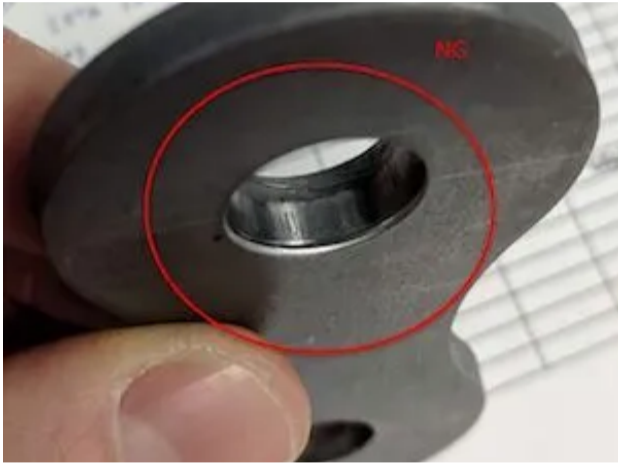
The customer was experiencing shear break stamping issues on the holes of their chain link.

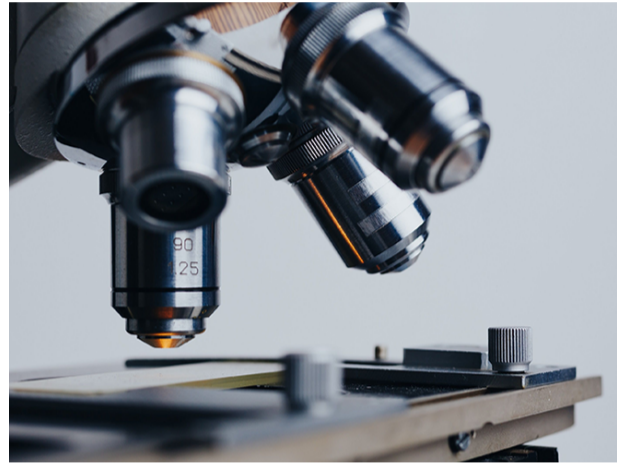
The Materials Support team analyzed the steel and discovered that there was a variation in hardness between the steel on the outside of coil, and the steel in the center of coil. Testing revealed that this hardness variation was due to an inconsistent microstructure, which occurs with uneven cooling of the coil.

The customer's stamping problem was alleviated by implementing adjustments to the cooling process at the hot mill. This prevented the hardness variation responsible for the stamping issue.
