Coating Adherence on Tubing

Learn how our Material Support & Solutions team solved this customer material issue.

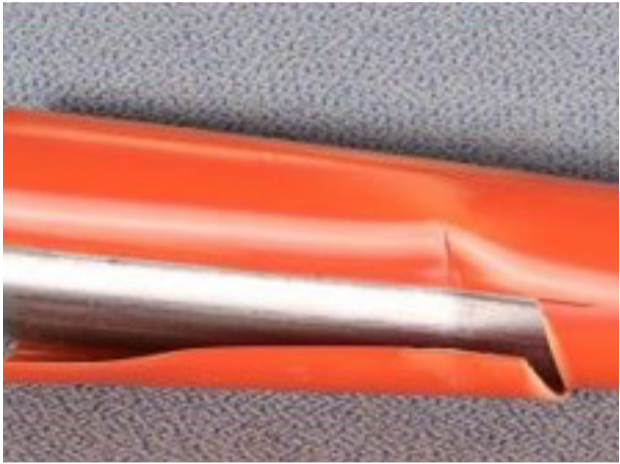
The customer roll formed electro-galvanized steel to make their tubing product and applied a proprietary plastic coating to the tube's exterior. Field issues and internal rejections began to mount due to adherence problems between the plastic coating and the steel tube.

Worthington helped the customer mitigate contaminant build-up. Raw material trials were proposed and executed to assist the effort. The customer was able to identify processing improvements to mitigate contaminates, resulting in the successful adhesion of the plastic coating.

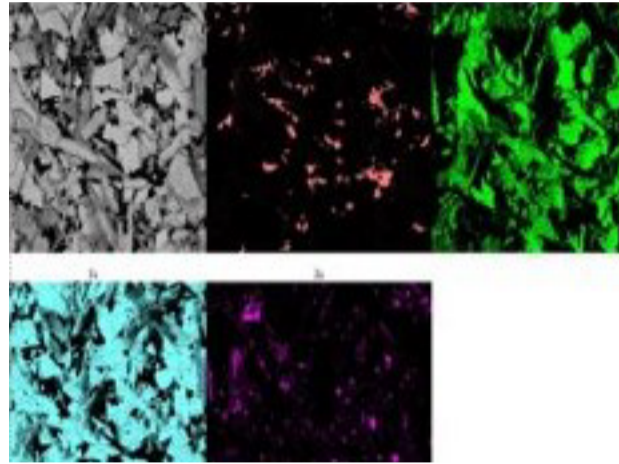
The cause of the adhesion issues were assessed at the Worthington Steel lab, utilizing Scanning Electron Microscopy (SEM)-EDX analysis. Contaminants in the customer's process were identified as the root cause of the loss of adherence.
