Shear-break Issue

Learn how our Material Support & Solutions team solved this customer material issue.

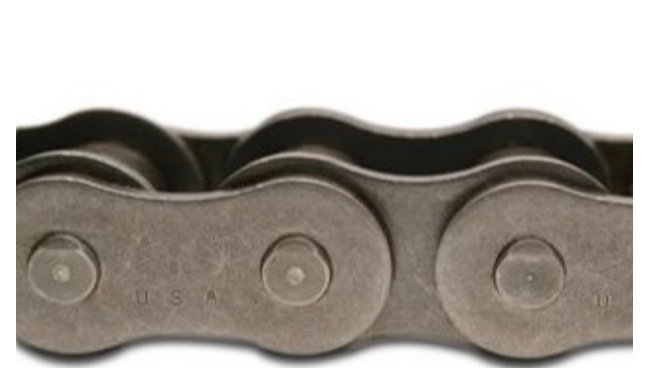
The customer was experiencing shear break stamping issues on the holes of their chain link.

The Materials Support team analyzed the steel and discovered that there was a variation in hardness between the steel on the outside of coil, and the steel in the center of coil. Testing revealed that this hardness variation was due to an inconsistent microstructure, which occurs with uneven cooling of the coil.

The customer's stamping problem was alleviated by implementing adjustments to the cooling process at the hot mill. This prevented the hardness variation responsible for the stamping issue.
